Urban Heritage Decline: Conservation Challenges in the Historic Town of Chukai, Terengganu, Malaysia

Nor Zalina Harun

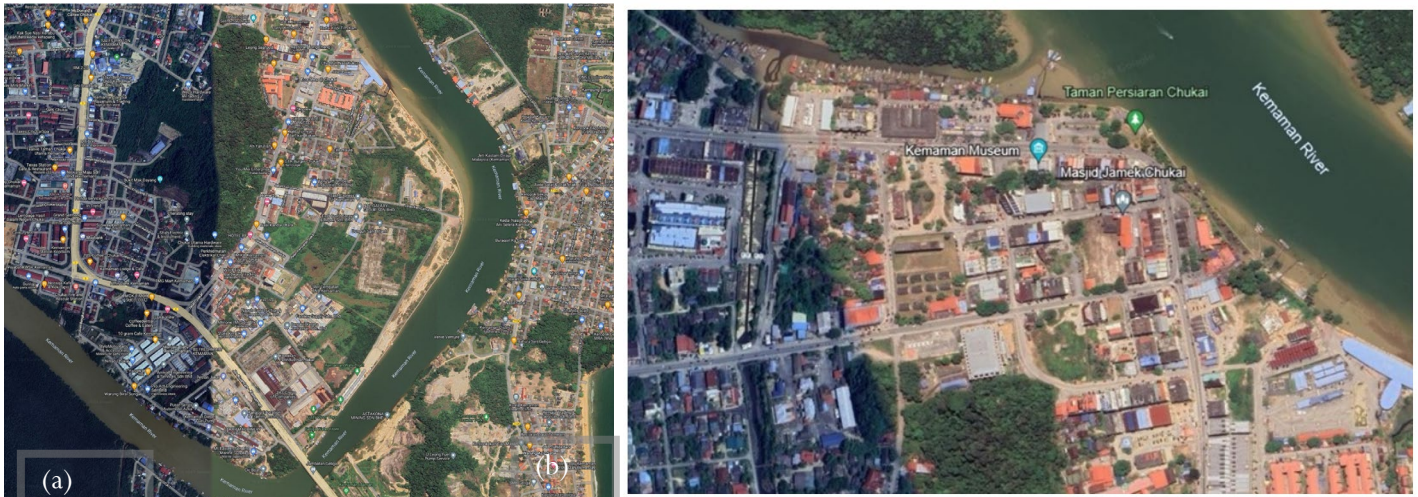
Figure 2 : (a) Map of Bandar Chukai (b) The site of the case study along the waterfront

This study was conducted in an old town located in the southern part of Terengganu, namely Bandar Chukai. Serving as the administrative center of Kemaman District — the southernmost district of the state — Bandar Chukai is situated adjacent to both the South China Sea and the Kemaman River (Figure 2). Geographically, it is positioned at latitude $4^{\circ} 14' 9.4''$ north and longitude $103^{\circ} 25' 15.6''$ east. The town holds considerable significance for Terengganu's tangible heritage and historical narrative, given the presence of numerous historic buildings within its vicinity.

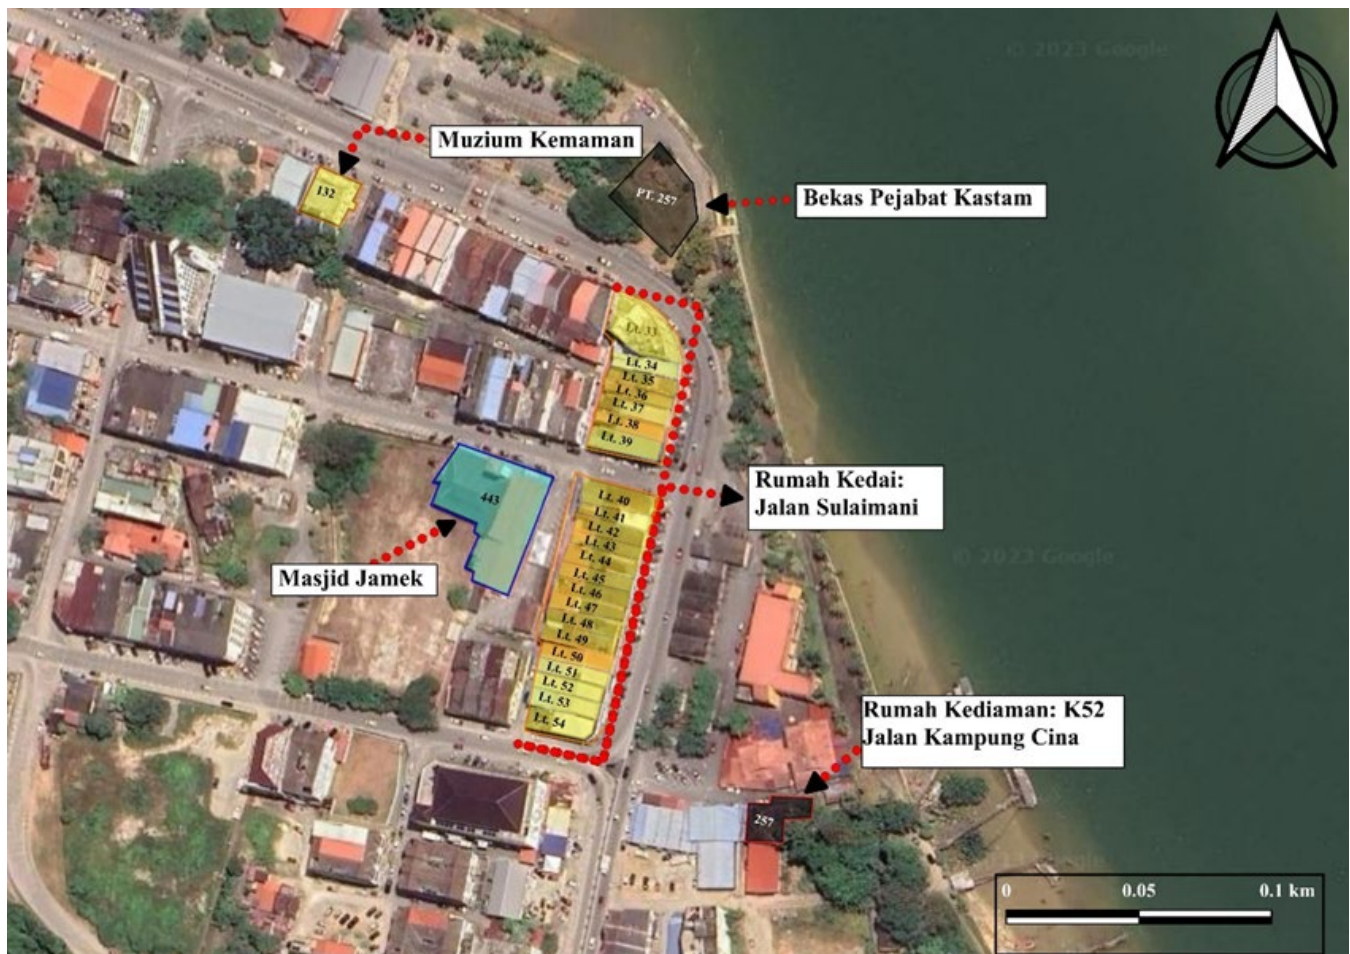
Figure 3 :This map highlights the positions of the buildings that have been successfully identified within the town of Chukai, with the exception of the Kampung Cina and Siew Distillery sites, as the existence of these structures could not be verified.

However, despite this recognition, significant gaps in conservation practices threaten the preservation of Chukai's heritage assets. These include insufficient focus on smaller, less prominent buildings, inadequate enforcement of conservation policies, and a lack of comprehensive planning frameworks. Heritage conservation in Malaysia often favours iconic structures, such as mosques and government buildings, while sidelining other historically significant but less prominent assets (as shown in Figure 3 below).
